**Inspection Date:** 08-14-2014

Palladino Home Inspection, LLC

Welcome and thank you for choosing Palladino Home Inspection, LLC. Experience and integrity at work for your piece of mind.

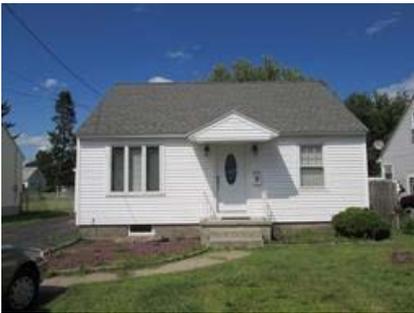
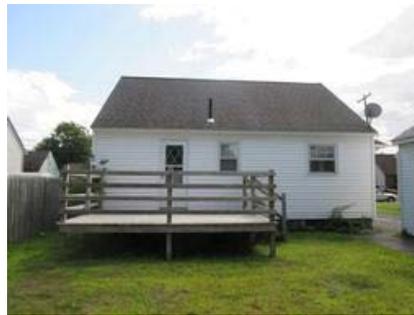
08/14/2014 One or more gutters are missing. Recommend installing gutters, downspouts and extensions such as splashblocks or a drain line to carry rain water away from the house

No gutters

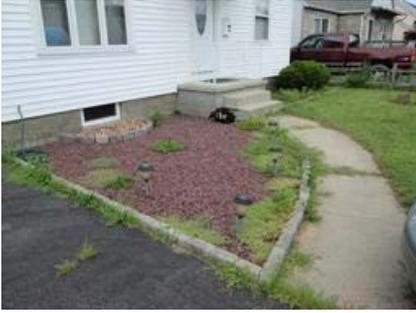
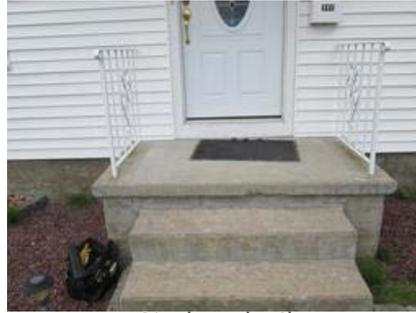
08/14/2014 There was no hand rail present on the steps entering the house. This is a safety concern. Recommend contacting a general contractor to evaluate.

No handrail

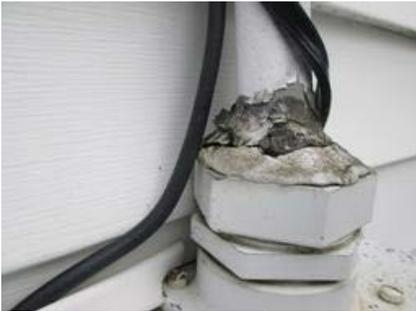
08/14/2014 Meter caulking is insufficient and needs to be recaulked. Moisture penetration is possible. Recommend a qualified contractor repair as necessary.

Cracked caulking Above meter

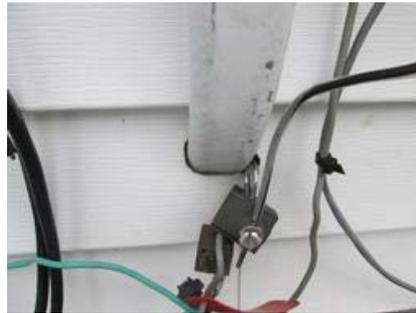
Missing Caulk below meter

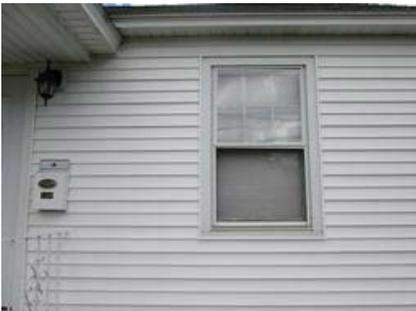
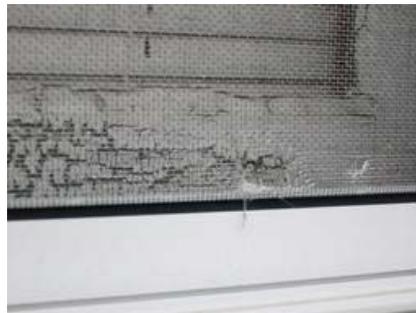
08/14/2014 It was noted at the time of the inspection that one or more screens have been damaged. It is recommended that a qualified contractor be contacted to repair as needed.

Holes in screen

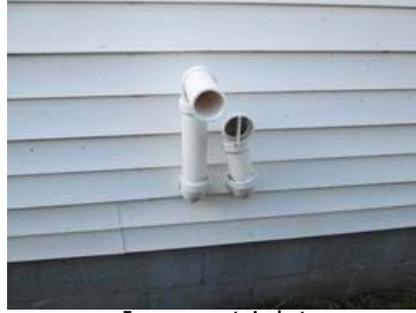
08/14/2014 At the time of the inspection it was noted that the high efficiency piping appeared to be installed in manor that is not standard business practice. It is recommended that a qualified contractor be contacted to repair as needed. NOTE: The inlet should be facing down. In the picture shown the inlet and the exhaust are both facing outward.

Incorrect inlet

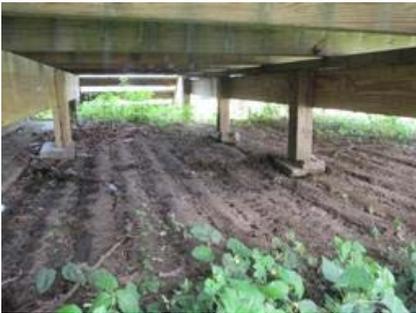
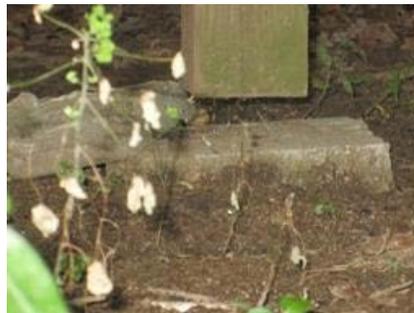
It was noted at the time of the inspection that one or more of the decks support columns was supported properly. This could compromise the stability of the deck if not addressed properly. It is recommended that a general contractor be contacted to repair as needed.

Gap between column support and ground

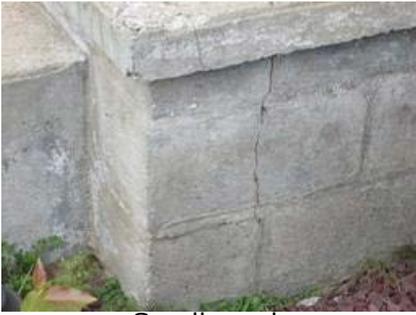
Noted cracks in foundation. This can allow water infiltration which will lead to further damage. Recommend qualified contractor to fix and repair as necessary.

Small crack

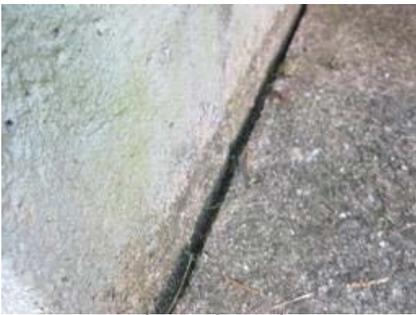
At the time of the inspection, it was noted that there was a gap/space between the ground and the foundation. This could lead to water infiltration. It is recommended that this gap is filled (either by yourself or a qualified contractor) to prevent any deterioration of the foundation.

Gap along foundation

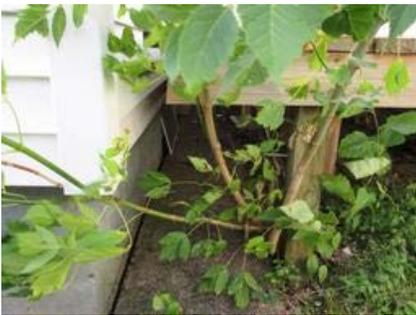
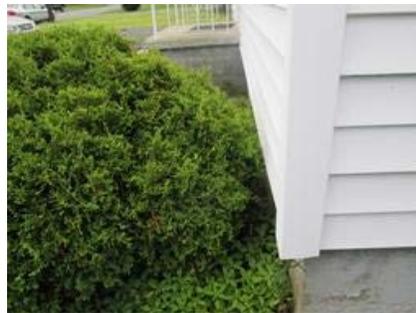
Shrubs are in contact with siding. Recommend pruning or moving shrubs so there's at least a one foot gap between shrubs and siding.

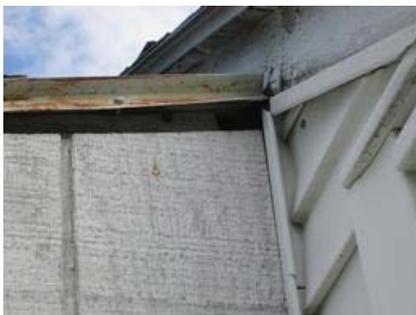
08/14/2014 At the time of the inspection it was noted that there was damaged trim. This could lead to water infiltration or pests. It is recommended that a qualified contractor be contacted to repair as needed.

Gap in trim

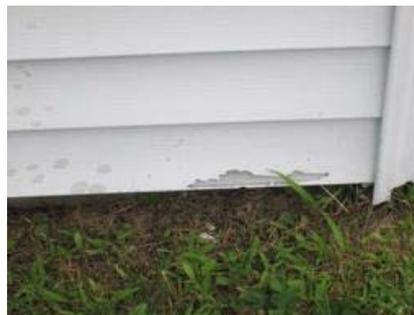
Damaged trim

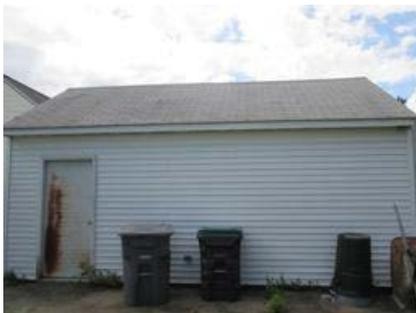
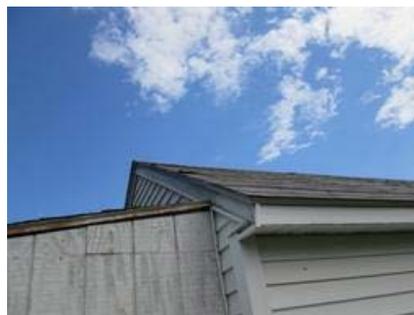
08/14/2014 Recommend installing gutters, downspouts and extensions such as splash blocks or a drain line to carry rain water away from the garage.

No gutters

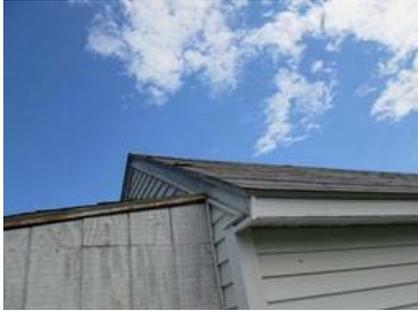
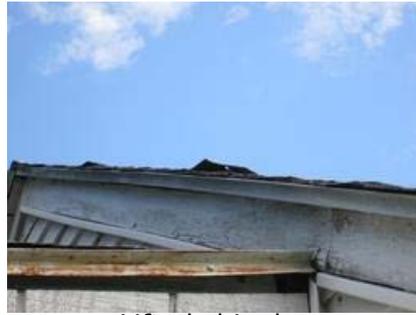
08/14/2014 At the time of the inspection it was noted that there was one or more lifted shingles. This may lead to water infiltration and damage the decking underneath. It is recommended that a qualified contractor be contacted to repair as needed.

Lifted shingles

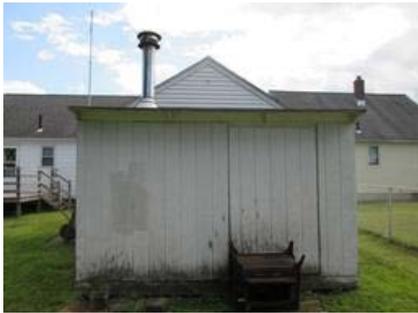
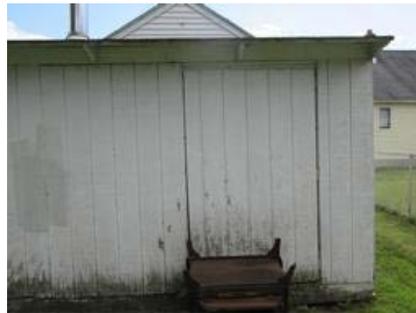
08/14/2014 At the time of this inspection, the rear door to the garage had no lock and was closed using a heavy object. This could lead to theft, or possibly pest intrusion. It is recommended that a lock be installed.

No lock on rear door

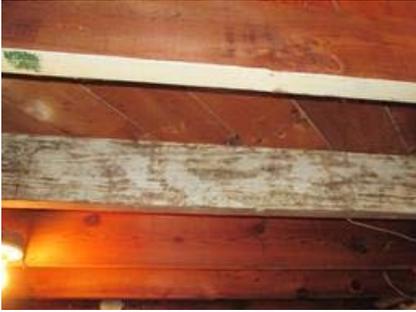
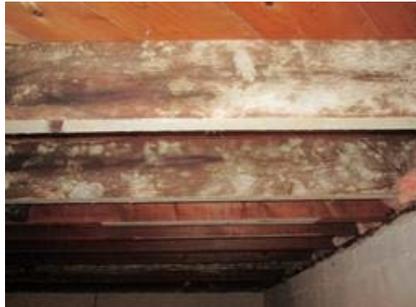
08/14/2014 At the time of the inspection it was noted that there was some biological growth like substance on one or more rafters. This could lead to health hazards if left in its current state. It is recommended that a qualified mold/mildew inspector be contacted to advise further.

White substance on floor joist(s)

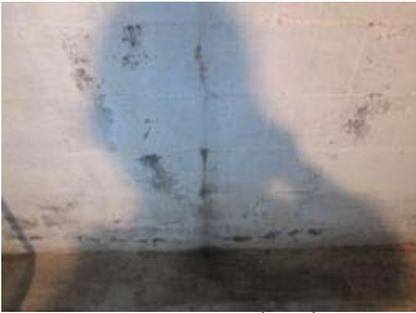
08/14/2014 Some beginning signs of moisture on foundation walls. Recommend gutters be installed on house to keep water away from foundation.

Water stain/trail

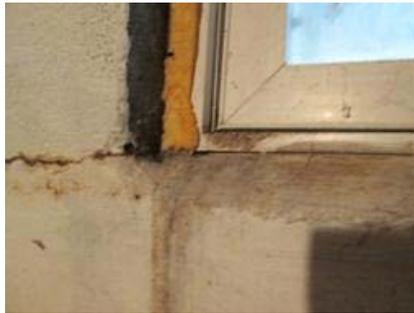
Water stain

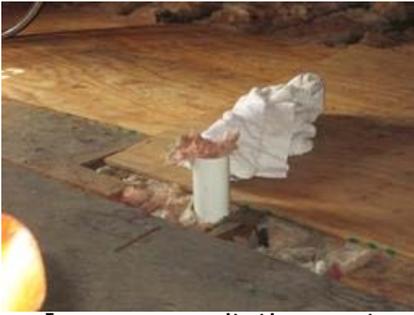
08/14/2014 It was noted at the time of the inspection that the sanitation vent was improperly terminated to vent into the attic. This is a non standard building practice, and could lead to mold/mildew issues in the attic. NOTE: There are more pictures related to the possible effects of this vent being improperly terminated in the attic in the "Attic" section of this report.

Improper sanitation vent

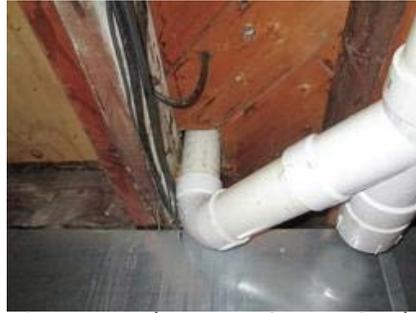
Sanitation vent that terminates in the attic

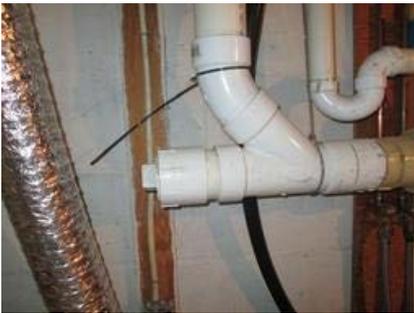
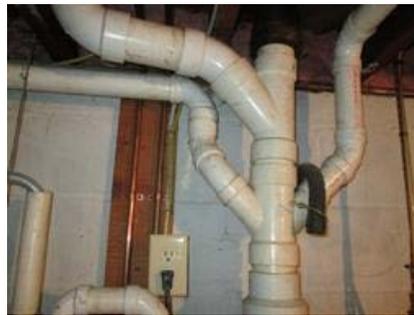
At the time of the inspection it was noted that the plumbing system had no trap. It is recommended that you contact a qualified plumber to evaluate the system with its current design to determine if it is adequate.

No trap

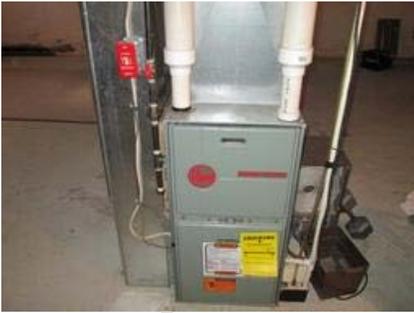
Furnace

Recommend that this system be serviced every year in the future by a qualified heating and cooling technician.

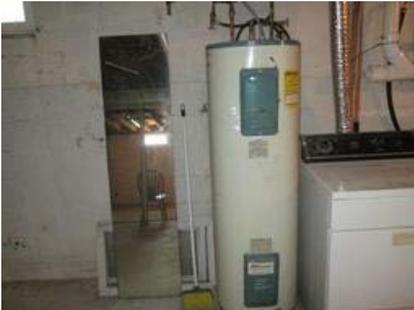
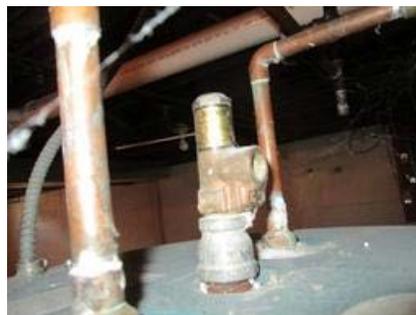
08/14/2014 Temperature-pressure relief valve is missing. Recommend having a licensed plumber install a temperature-pressure relief valve and drain line extending to within 6" from the floor, or routed so as to drain outside.

Missing relief valve

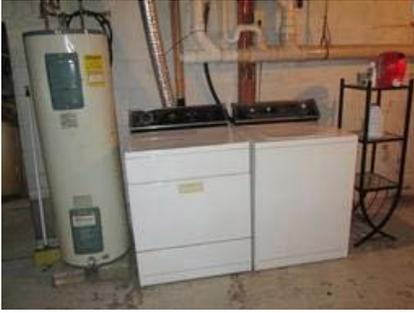
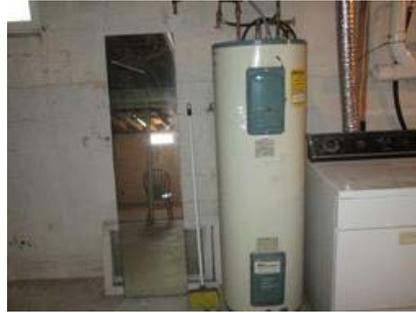
08/14/2014 Hot water heater appears to be older than 10 years and is older than its estimated useful life. This hot water heater may need replacing at any time.

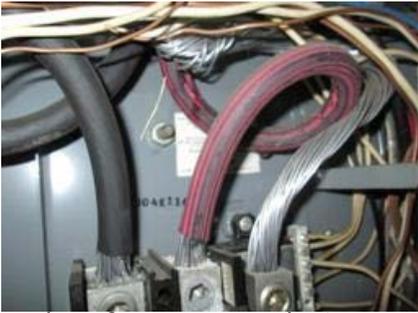
At the time of the inspection it was noted that there was water in the main panel. This is a safety hazard, as well as a potential repair greater than \$1500. It is recommended that a certified electrician be contacted to evaluate and repair as needed.

Droplet of water on red wire cover

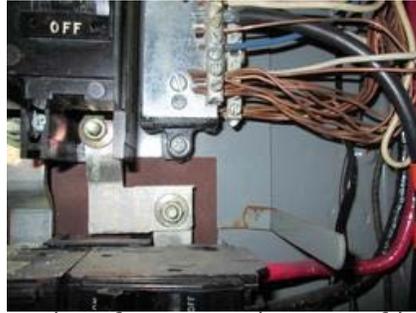
Droplet of water on bottom of bus

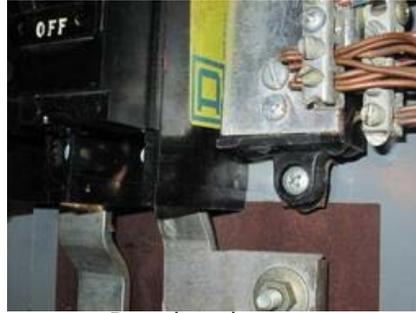
Droplet close up

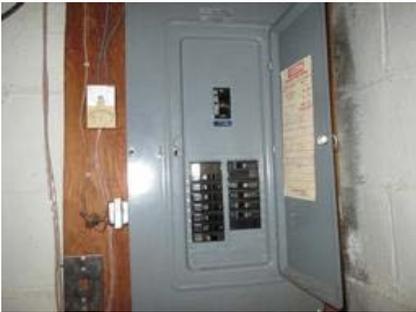
Main panel

08/14/2014 Extensive rust noted in Electric Service Panel. This can be hazardous. Recommend a licensed electrician repair or replace as necessary.

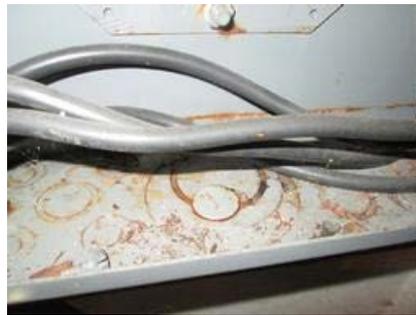
Rust

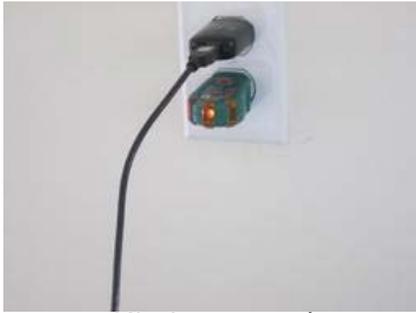
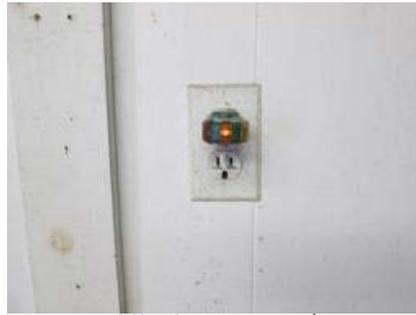
08/14/2014 Multiple outlets in house had open grounds. Three prong outlets that are ungrounded could be used with equipment that requires a ground to run properly such as computers and televisions. This could destroy such devices. Recommend a qualified contractor evaluate system and make recommendations for repair.

Missing ground

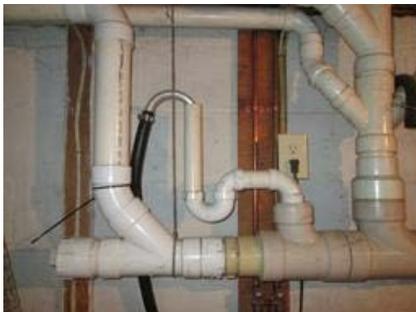
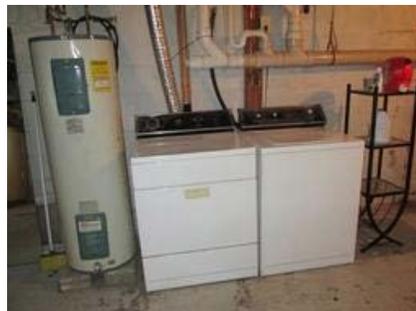
Drain pipe for the washer and electrical outlet were in close proximity. Possibility of a fire if overflow from the drain pipe. Also, the electrical outlet for the wash machine was not GFI, and needs to be if in close proximity to water. Recommend a qualified contractor and/or electrician repair as necessary.

Drain pipe/outlet proximity

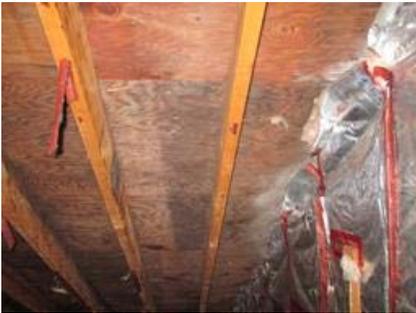
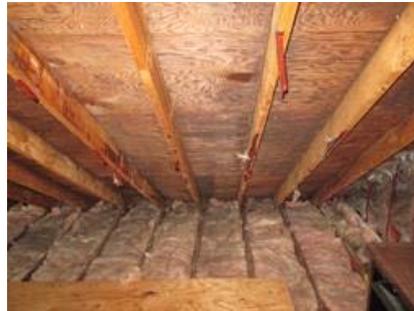
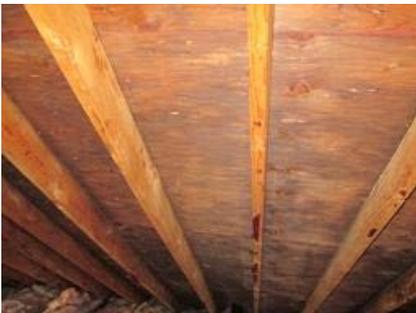
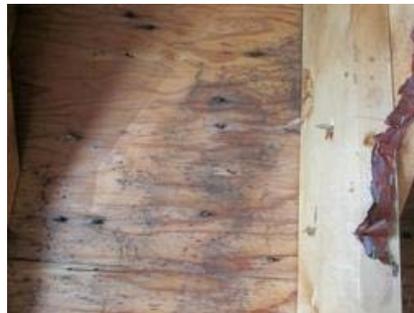
At the time of the inspection it was noted that there were one or more areas of the roofs decking that was covered partially with a "black" "mold like" substance. We do not inspect for mold. It is recommended that a qualified mold specialist be contacted to investigate further, and treat and repair as necessary.

Black substance

Black "mold like" substance

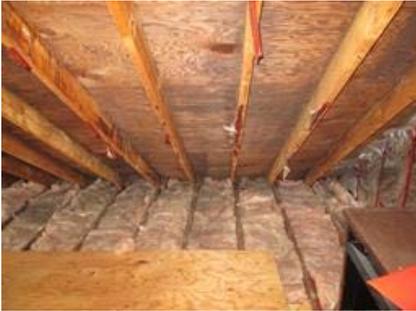
It was noted at the time of the inspection that there was improper insulation/venting found in the Attic. This could lead to potential moisture build-up, which can then turn into mold if not properly vented. It is recommended that a qualified general contractor be contacted to repair as needed.

Soffit vents covered

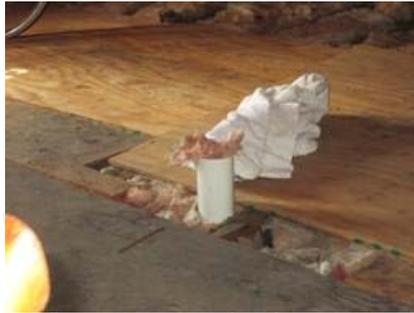
Improper sanitation vent

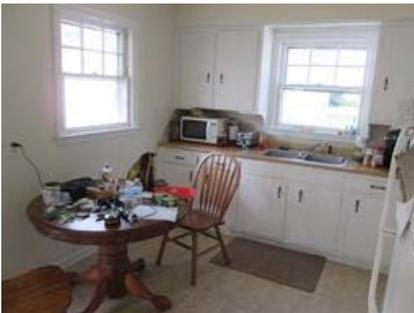
No ground fault circuit interrupter (GFCI) devices (outlets or circuit breakers) are visible for the kitchen. GFCI devices help prevent electric shocks in areas that may have water present. Recommend having a qualified, licensed electrician install GFCI protection for outlets, over counter tops and around sinks.

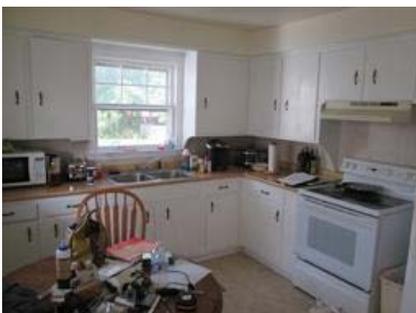
It was noted that there was no stoppers on the cabinet drawers. It is recommended that stoppers be installed to prevent injury or damage to the drawers if they fall out of place.

Each cabinet drawer needs a stopper

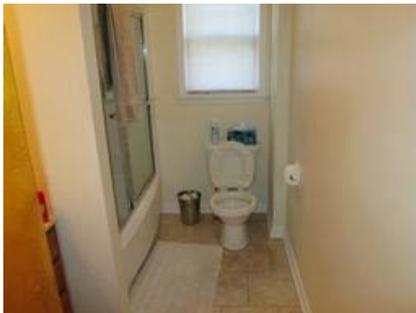
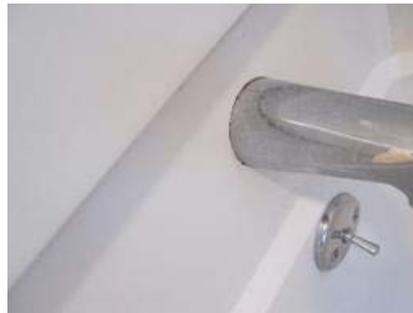
08/14/2014 Noted missing caulk in bathtub area. This will allow water penetration to effect sub flooring and may damage wood. Recommend a qualified contractor repair or replace as necessary.

Missing caulk around cut out around the tub faucet
