**Inspection Date:** 08-14-2014

Palladino Home Inspection, LLC

Welcome and thank you for choosing Palladino Home Inspection, LLC. Experience and integrity at work for your piece of mind.

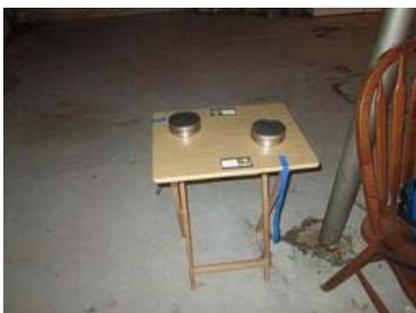
Radon canisters

08/14/2014 Canisters were sent to testing laboratory within two hours after completion of test. Results will be posted after canisters have been analyzed.
